Case Study: University Center Owen Choy

Executive Summary

This report details a simple building audit of the University Center (commonly referred to as “the UCen”) at the University of California Santa Barbara (UCSB). This case study presents a qualitative assessment of building features and practices of the building that was performed with reference to the US Green Building Council’s (USGBC) version 4 (v4) LEED Scorecard for Operations and Maintenance in school buildings. Water and energy analyses were conducted using the USGBC LEED v4 Indoor Water Use Reduction Calculator and ENERGY STAR Portfolio Manager to examine water and energy usage, respectively. Opportunities for operation and design improvements of the building were evaluated as well. Building Maintenance Manager Hugo Rios assisted me with this inspection by providing additional insight about the building.

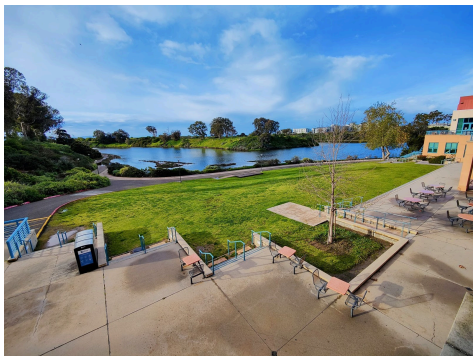
One way the design of the building site protects this area is with the Lagoon Lawn behind the building, which lies directly between the building and the lagoon. The lawn facilitates water absorption to prevent stormwater runoff from contaminating the lagoon. This protection design prevents pollutants and trash from flowing into the lagoon during storms. Additionally, large sections of the building roof are painted white to reduce the heat island effect, thereby minimizing the effect on microclimates.

The view of the Lagoon Lawn and the campus Lagoon from the UCen.

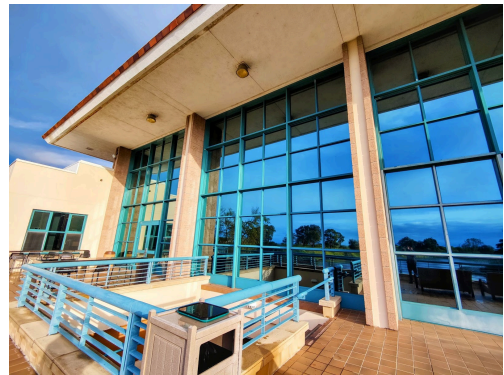
The UCen takes advantage of the direct sunlight it receives throughout the day by balancing the amount of sunlight used for natural lighting and heating. This practice minimizes energy usage during the day. A large array of south-facing windows on the main floor allow in a comfortable amount of light, removing the need for artificial lighting. Multiple large skylights throughout the building bring natural light into the second and third floors, and high ceilings allow sunlight to radiate further.

An assembly of tinted windows on the UCen's main floor facing the south side with a large awning.

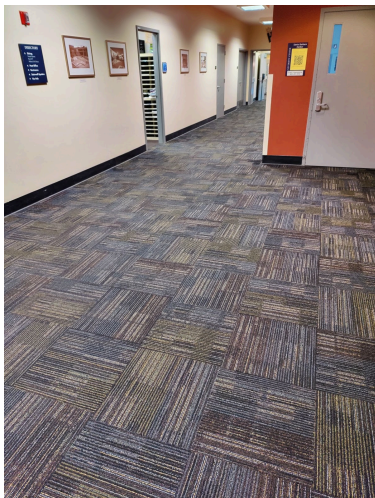
The UCen prioritizes sustainability in this category through its restaurants. Every eatery offers cutlery made out of biodegradable materials. This includes biodegradable plastic and paper containers. Additionally, some parts of the building are floored with carpet tiles, which is beneficial since individual tiles can be removed instead of the entire carpeting when replacement is needed. The third floor was also recently renovated, which removed asbestos from the building insulation.

An array of carpet tiling on the main floor of the University Center.

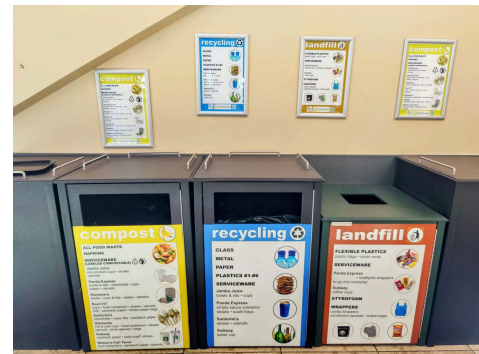
Additionally, the building features separated trash receptacles that split waste into recyclables and compostable waste. There is even a distinguished receptacle for battery disposal. Each container is marked with informational signage to encourage occupants to dispose of waste in the appropriate bins. This reinforces the UCen's commitment to maintaining sustainable building practices.

Compost, recycling, and landfill receptacles on the first floor.
